CASE REPORT

Spontaneous Hemorrhage Leading to Loosening of the Tibial Component after Total Knee Arthroplasty: A Case Report

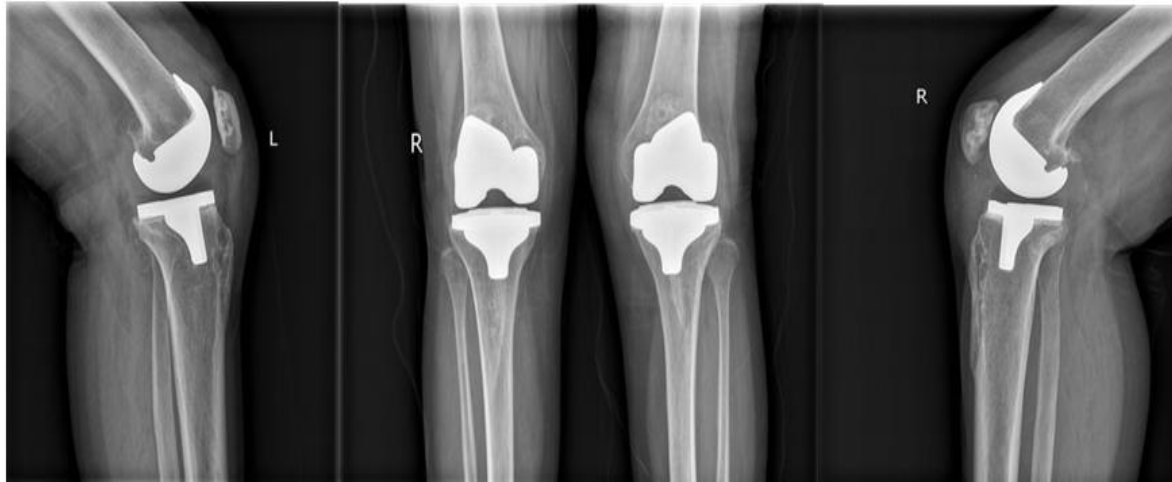
the swelling subsided. Today, the pain and swelling of the left knee suddenly worsened, accompanied by limited mobility. Therefore, she came to our hospital for treatment and was admitted to our department as "pain after left knee arthroplasty" in the outpatient department. X-ray examination showed that "the artificial joint was in place, well anastomosed, the space was of equal

width, the distal end was basically filled in the medullary cavity, and the surrounding soft tissues were swollen. The relationships between the bilateral femurs, tibias, fibulas, hip joints and ankle joints were good. The bone structure was complete, the bone cortex was smooth and continuous, and the space was normal" (Figure 1).

Figure 1 Preoperative anteroposterior and lateral radiographs of the left knee

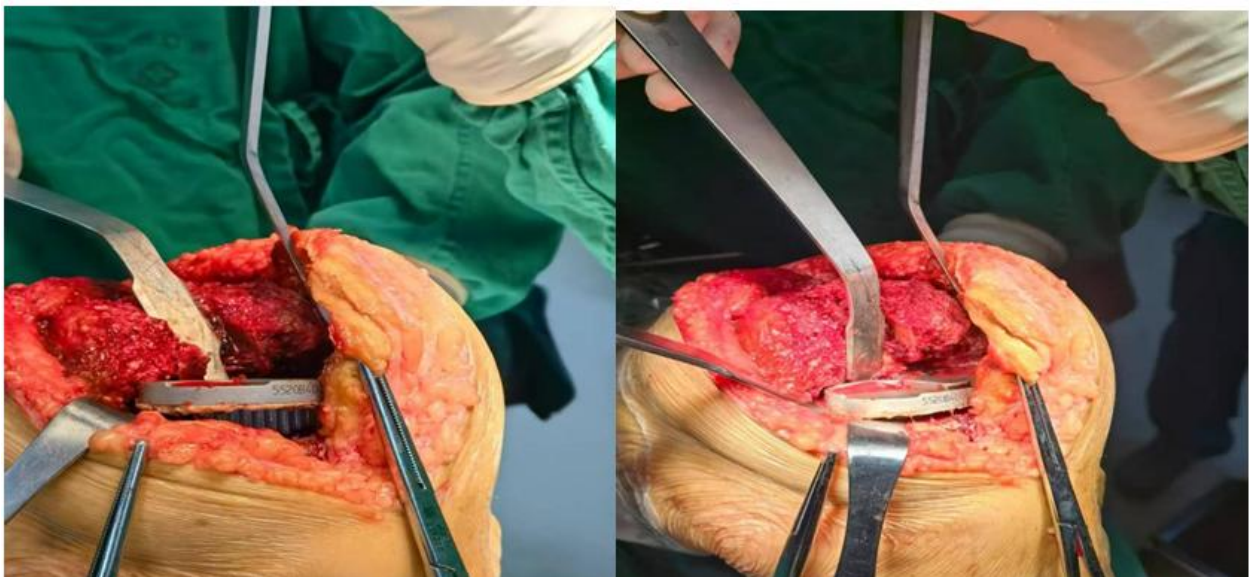
A large amount of hyperplastic synovial tissue around the knee joint was completely removed to achieve the "naked" degree. After cleaning, the wound was repeatedly irrigated 3 times with povidone-iodine, hydrogen peroxide and normal saline. The tibial side prosthesis was completely

loose (Figure 3) and was removed by hand. On the femoral side, an elastic osteotome was used to remove the bone cement between the prosthesis and the bone, and the femoral prosthesis was removed.

Figure 3 Intraoperatively, loosening of the tibial-side prosthesis caused by spontaneous bleeding in the knee joint was observed

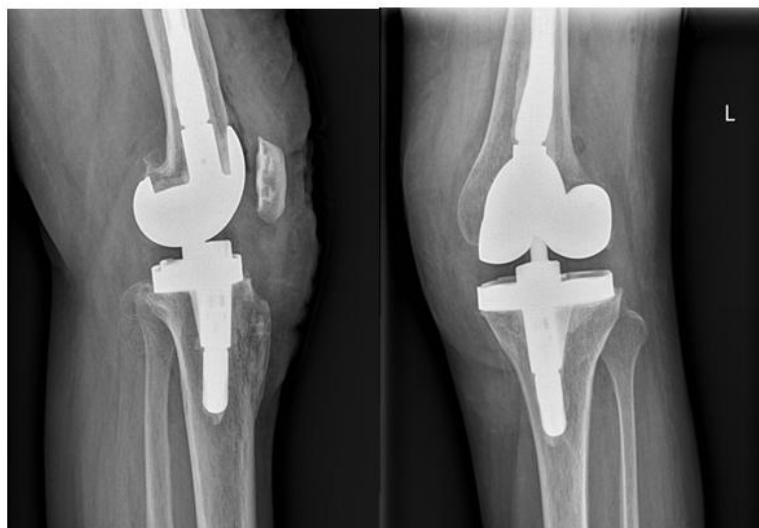
added to the lateral side of the distal end of the femur to supplement the bone defect at the distal end of the femur, and 5-mm titanium alloy spacers were added to the medial and lateral sides of the tibia. After the bone cement was allowed to set in the extended position, the wound was irrigated with a large amount of normal saline, concentrated povidone-iodine and one bottle of chitosan quaternary ammonium salt biological colloid solution to prevent wound infection. It was found that there was a large amount of bleeding from the soft tissues of the knee joint. An absorbable medical hemostatic membrane was used for hemostasis treatment on the bleeding wound surface. After checking that the number of dressings and instruments was correct, a negative pressure drainage tube was placed in the knee joint cavity, and an extension rod (used for injecting drugs into the joint cavity) was also placed. The joint capsule was sutured strongly at a flexion angle of 60 degrees, and the incision was sutured layer by layer. After suturing the wound, a piece of wound dressing was placed on the wound to promote wound healing. The patient was safely returned to the recovery room after the operation. Postoperative X-ray reexamination showed that "the prosthesis was in place, well anastomosed, the distal segment of the prosthesis was basically filled in the medullary cavity, the surrounding soft tissues were swollen and gas shadows were seen, the knee joint was slightly valgus, and the bone density of the patella was uneven. The relationships between the left femur, tibia, fibula, hip joint and ankle joint were good, and the space was normal" (Figure 4).

Figure 4 Postoperative radiograph following revision arthroplasty
