Experimental Study on Scarf Repair of Composite Laminates under Different Loading Conditions

Du Long^{1*}, Li Chaoguang¹, Wang Hongfei¹

Hongdu Aviation Industry Group, Nanchang, PO Box 330024, Jiangxi, China

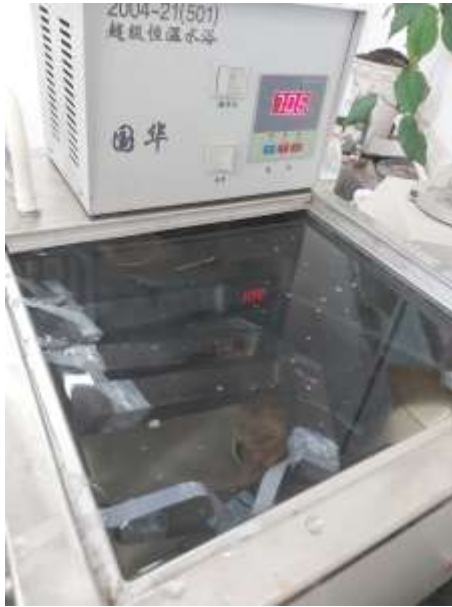
Fig 4 Water bath device

The specimens for ETW test were first subjected to 14 days of aging treatment in a constant temperature water bath at 71°C, the water bath device was shown in Fig 4, and then these specimens were tested at 71°C. The low temperature was -55°C. The test setup is shown in Fig 5. The RTD test was performed on an

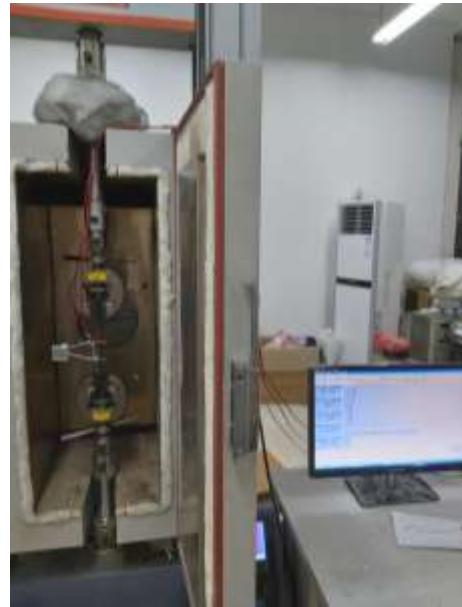
Fig 5 Experimental set-up for CTD testing

INSTRON8801 universal test machine, and the high and low temperature tests were performed on a WDW-50C universal test machine. The test loading rate was 0.5 mm/min, and the specimen deformation was measured continuously using an extensometer and strain gauges, where the extensometer was clamped on the bonded section to accurately measure the repair stiffness.

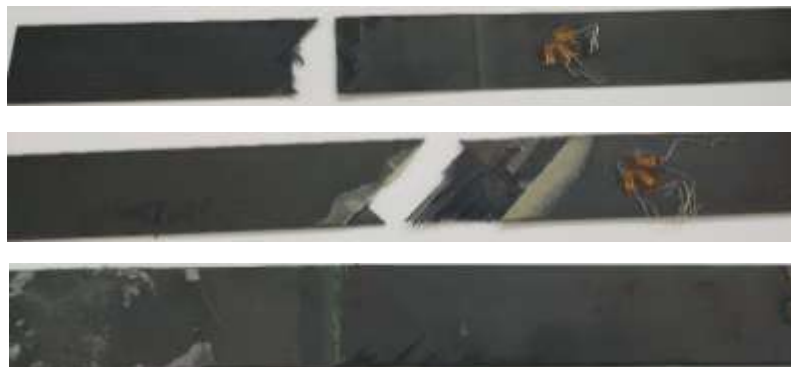
Fig 6 Failure modes in repaired specimens

The fracture specimens showed that the main failure modes included cracking of the adhesive layer and fracture of the additional plies (Fig 6). For the tensile specimens, the adhesive surface was under shear and out-of-plane peeling stresses, the failure began to appear on the side without

additional plies, followed by the rapid propagation of the adhesive cracks. Eventually, the entire adhesive surface was debonded and the additional layers were damaged in shear. For the tensile-shear specimen, the failure process was similar, but because the additional plies were ($\pm 45^\circ$) layers, the failure of the additional plies was tensile failure.

Compared with RTD and ETW environments, low temperature increased the brittleness of the adhesive and additional plies, and they were quickly pulled apart, resulting in a sudden destruction of the specimen. For the specimens treated by ETW environment, debonding

appeared between the fiber and matrix in additional plies. It can be explained that the additional plies were thin and the higher moisture absorption rate of the adhesive layer.
